Polymer-Coated Corrugated Steel Pipe

100-Year protection against abrasion and corrosion

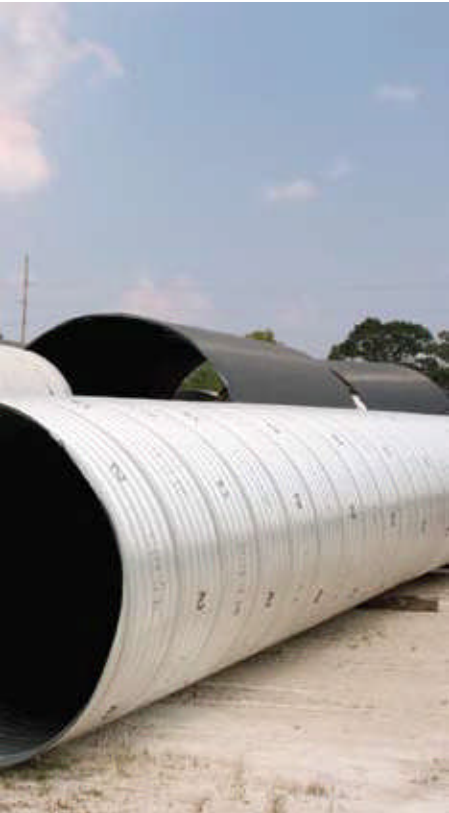
Installed in 1975 by the Arkansas State Highway Department as a test installation, this 66"-diameter TRENCHCOAT corrugated steel pipe remains in excellent condition. After 31 years of exposure to pH 5.5, sediment and moderate abrasion, the triple-barreled structure keeps on performing. Also, test sites in Michigan, Wisconsin and New York—under harsh conditions—demonstrate the superb performance of TRENCHCOAT.

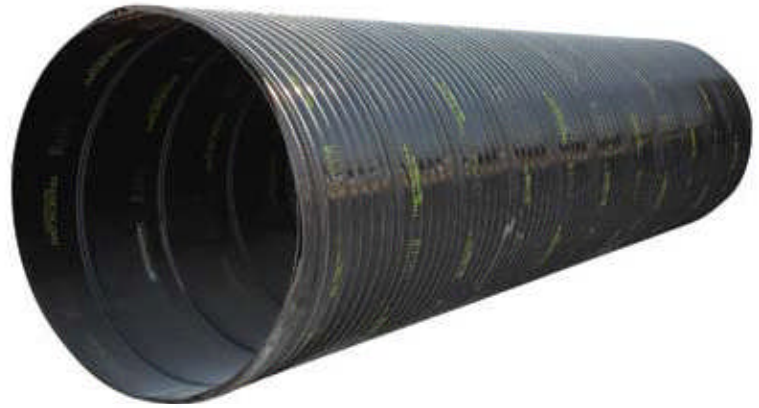
Service Life	pH Levels	Resistivity
100 Years	5-9	1,500 ohm.cm>
75 Years	4-9	750 ohm.cm>
50 Years	3-12	250 ohm.cm>

The Dow Chemical Company has conducted field studies of corrugated steel pipe with its TRENCHCOAT heavy-gage protective film—under various environmental conditions—at numerous sites throughout the United States. From this research, DOW predicts the following service life expectancies:
